MACHINE SERVICE BULLETIN NO. 358

SUBJECT: Reversals
LA-5 and LA-6 Models

DATE: July 19, 1940

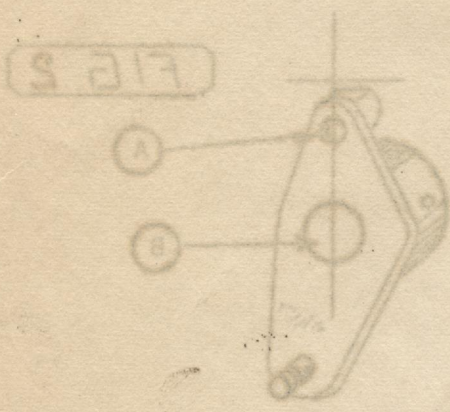
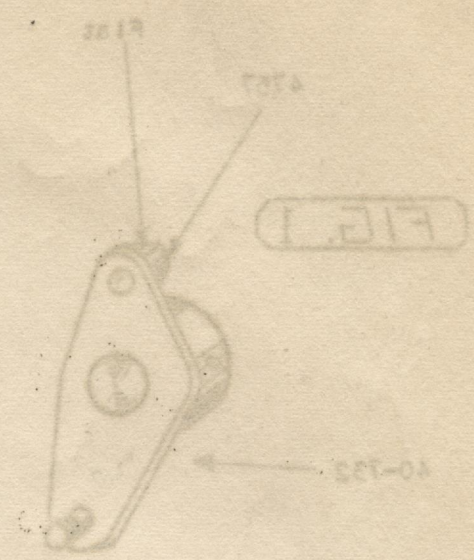
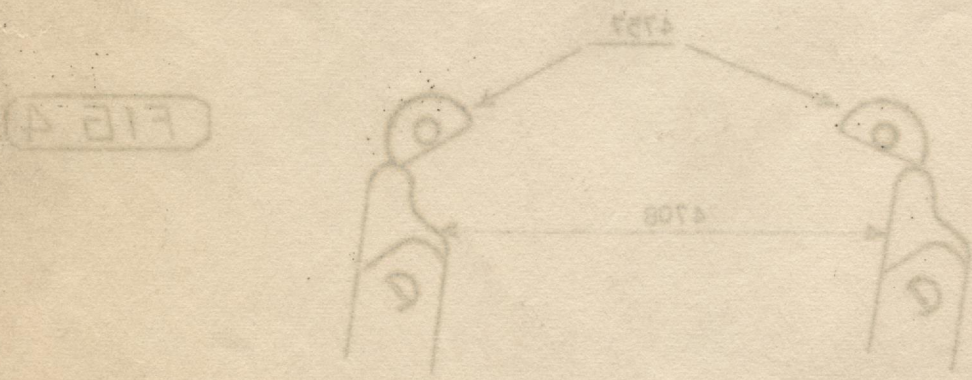
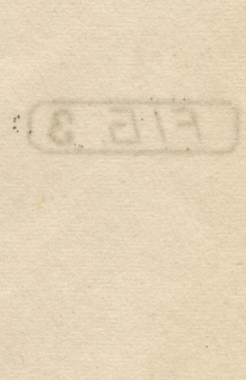
The 4757 stud on the 40-732 and 41-732 crank arm of the carry shaft has a flat side which serves the purpose of retarding the clutch yoke until the proper time for it to move its position from plus to minus or vice versa. See Fig. 1.

The two edges of this flat side move the clutch yoke into the plus or minus position according to the direction the machine starts to cycle. As the 40-732 or 41-732 turns, the edge of the flat side will contact the center point of the top of the 4708 blank and cause the yoke to move into the position desired (provided the 4708 is correctly adjusted) and the flat of the 4757 stud will prevent movement of the yoke in the wrong direction if it should receive a rebound from some source. See Figures 3 and 4.

If reversal trouble is encountered, inspect the 40-732 crank arm to determine if the flat of the 4757 stud is located at a right angle to a line drawn through the center of shaft (B) and rivet (A). See Figure 2. If for some reason the flat is positioned otherwise, remove the 40-732 or 41-732 and while held in a vise, turn the stud to the proper position with pliers, after which retighten the rivet or replace the 40-732 or 41-732 with another.
